Asbestos Management Plan

Bailup Equestrian Centre Clubrooms –
Bailup Road,
Woorloo WA 6558

6 February 2024

Bailup Equestrian
Centre Clubrooms

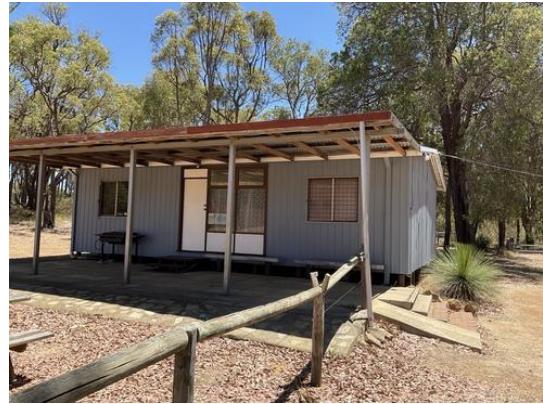
Photo 2

Shadowline External Cladding

ACM suspected
Hardies Shadowline
Good
Sealed and intact
100
Non-Friable
Accessible: unlikely to be damaged

Monitor and review for wear and damages
