Shire of Mundaring

Asbestos Management Plan

Boya Oval Change Rooms & Toilet –
119 Scott Street,
Boya WA 6056

5 February 2024

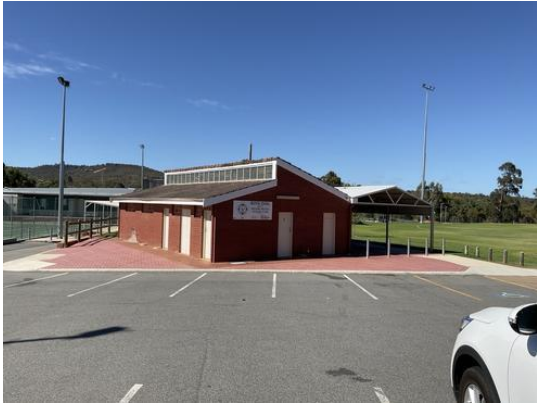
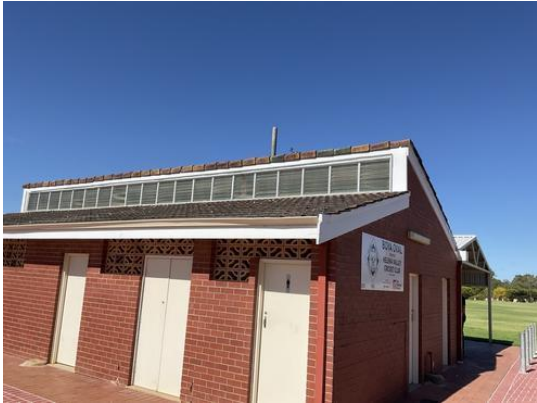
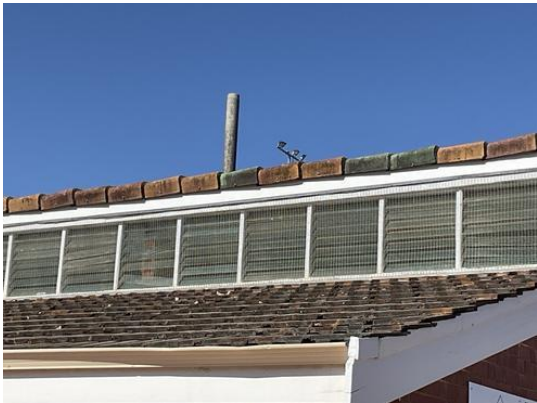
Photo 1

Asbestos Containing Material	ACM suspected	
Material type	AC flue and pipes	
Condition	Good	
Details on Condition:	Intact	
Quantity sqm (apx)	5	
Friable or Non-Friable	Non-Friable	
Is this an inaccessible area?	Only accessed by maintenance staff / contractors	
Actions for consideration:		
Consider safe removal & replace with non ACM	Consider sealing the ACM appropriately	Monitor and Review the ACM's condition
	Consider safely sampling the ACM for verification	Signify ACM present

Removal by a licenced asbestos contractor during refurbishment or demolition
 Monitor and review for wear and damages

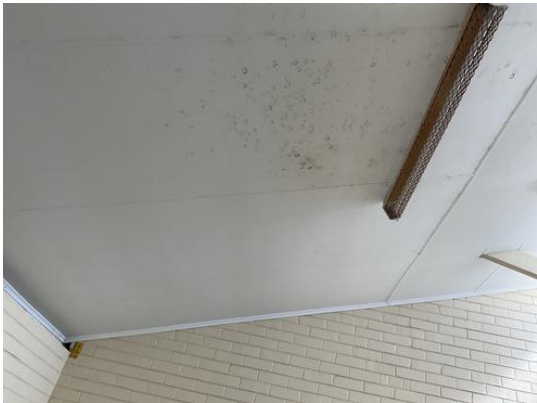
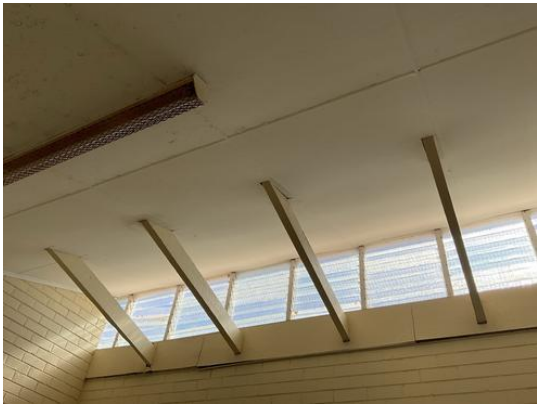
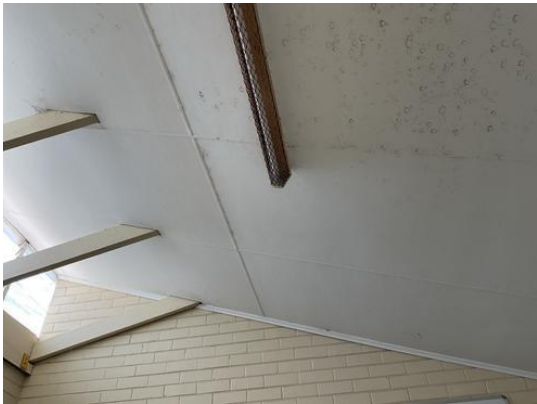
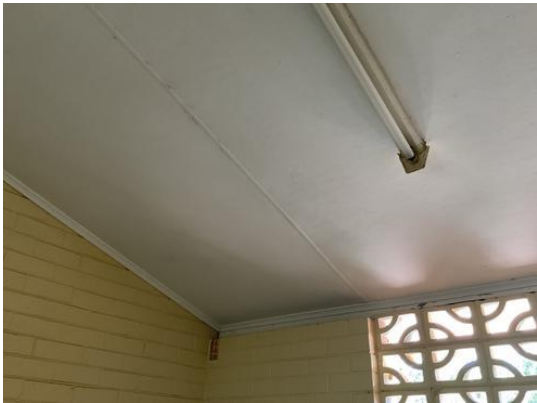
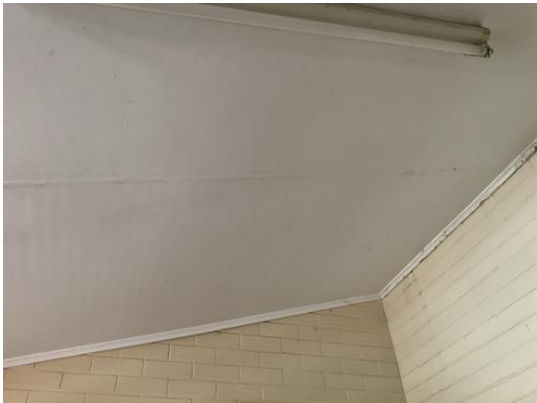
Photo 4	Photo 5
Photo 6	Photo 7
Photo 8	
Asbestos Containing Material	ACM suspected
Material type	Hardiflex sheeting
Condition	Good
Details on Condition:	Intact
Quantity sqm (apx)	100
Friable or Non-Friable	Non-Friable
Is this an inaccessible area?	Only accessed by maintenance staff / contractors
Actions for consideration:	
Consider safe removal & replace with non ACM	Monitor and Review the ACM's condition
	Consider safely sampling the ACM for verification
	Signify ACM present
Other details:	
Testing recommended	
Removal by a licenced asbestos contractor during refurbishment or demolition	
Monitor and review for wear and damages

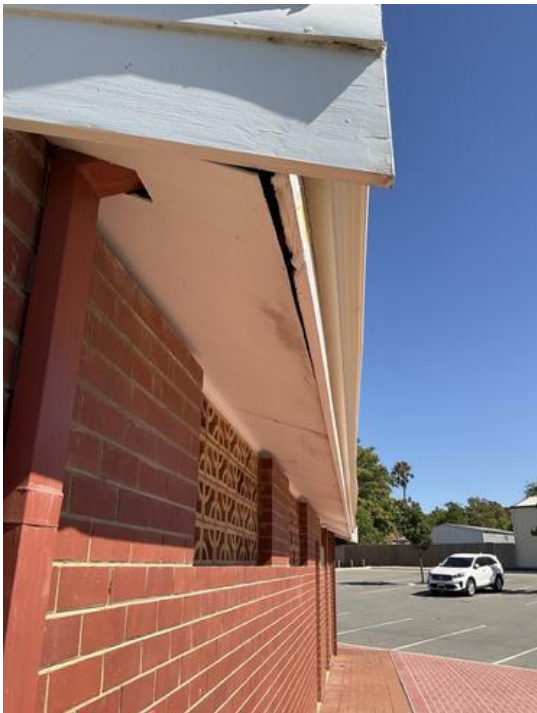
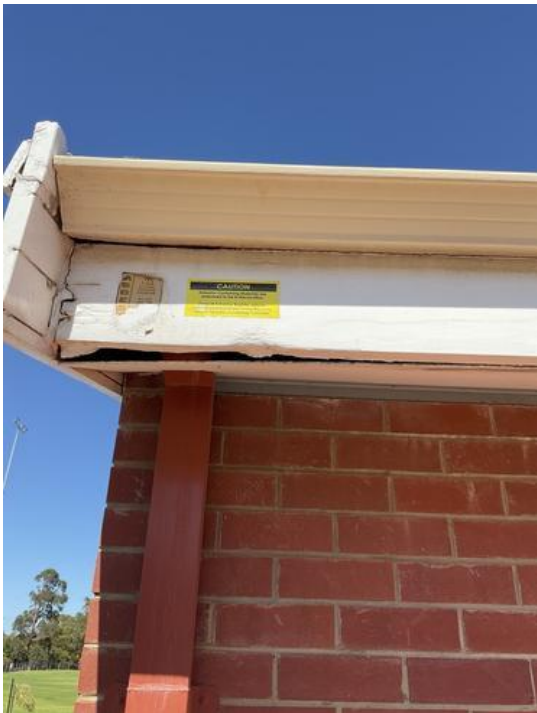
Photo 9	Photo 10	
Asbestos Containing Material	ACM suspected	
Material type	Hardiflex sheeting	
Condition	Good	
Details on Condition:	Intact	
Quantity sqm (apx)	5	
Friable or Non-Friable	Non-Friable	
Is this an inaccessible area?	Only accessed by maintenance staff / contractors	
Actions for consideration:		
Consider safe removal & replace with non ACM	Consider sealing the ACM appropriately	Monitor and Review the ACM's condition
	Consider safely sampling the ACM for verification	Signify ACM present
Other details:		
Removal by a licenced asbestos contractor during refurbishment or demolition		
Monitor and review for wear and damages

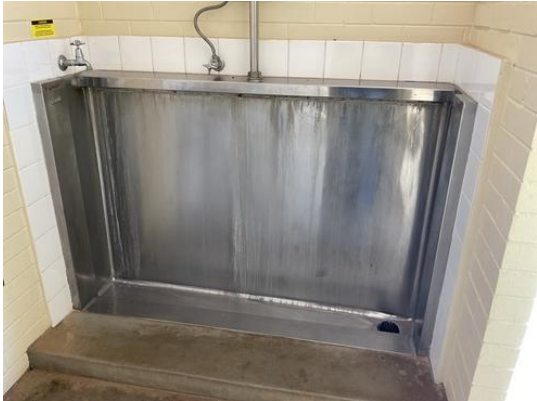
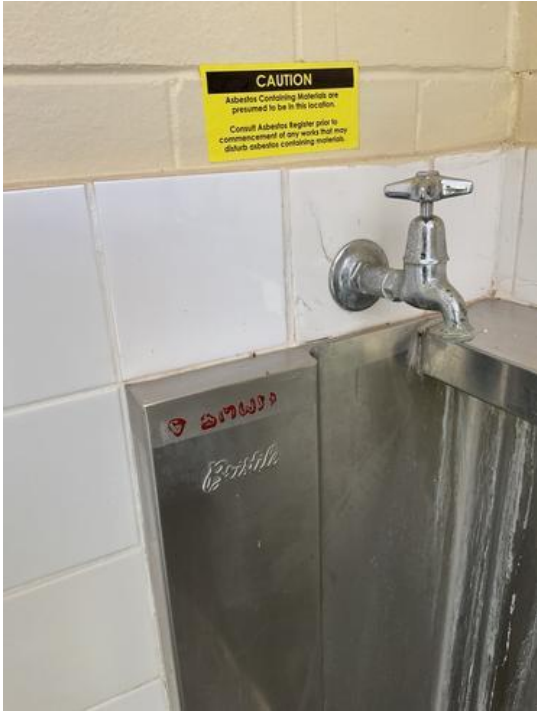
Photo 11	Photo 12	
Asbestos Containing Material	ACM suspected	
Material type	Other	
Details:	Blackjack spray resin backing	
Condition	Good	
Details on Condition:	Assumed intact	
Quantity sqm (apx)	2	
Friable or Non-Friable	Non-Friable	
Is this an inaccessible area?	Only accessed by maintenance staff / contractors	
Actions for consideration:		
Consider safe removal & replace with non ACM	Monitor and Review the ACM's condition	Consider safely sampling the ACM for verification
		Signify ACM present
Other details:		
Monitor and review for wear and damages		
Removal by a licenced asbestos contractor during refurbishment or demolition

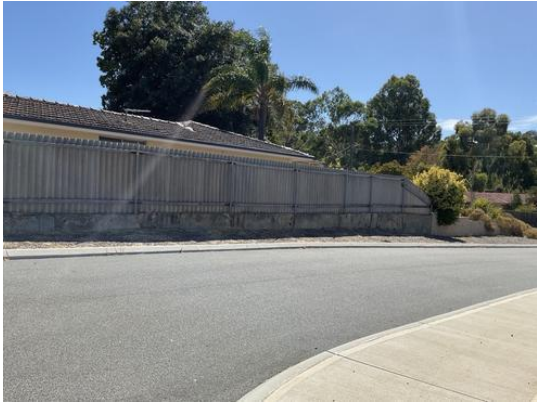
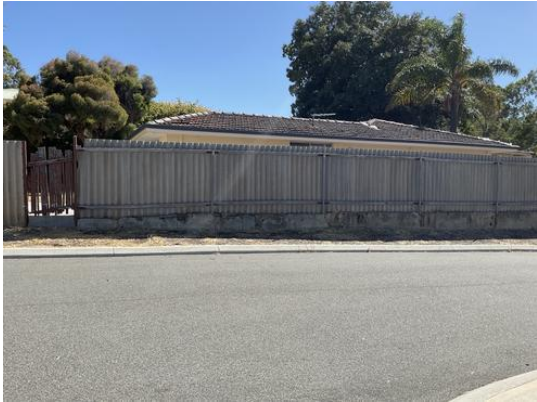
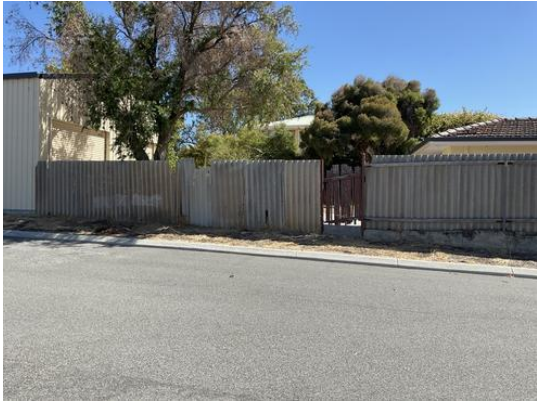
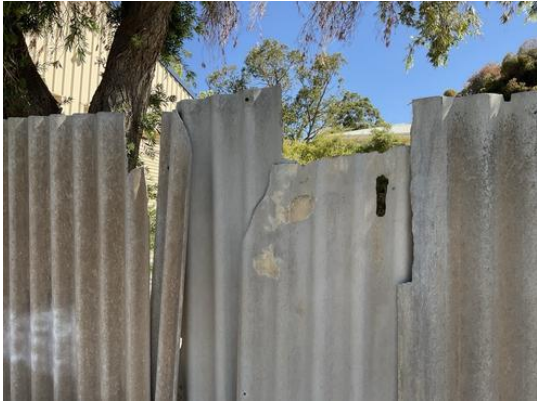
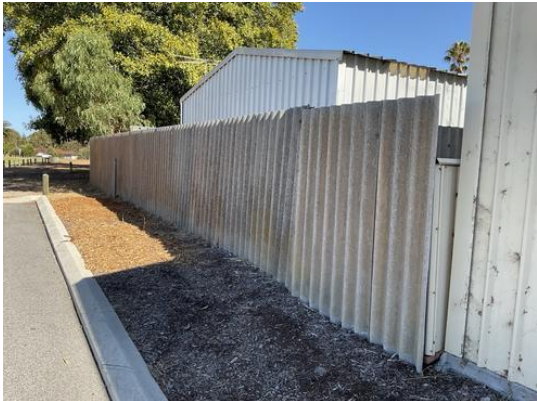
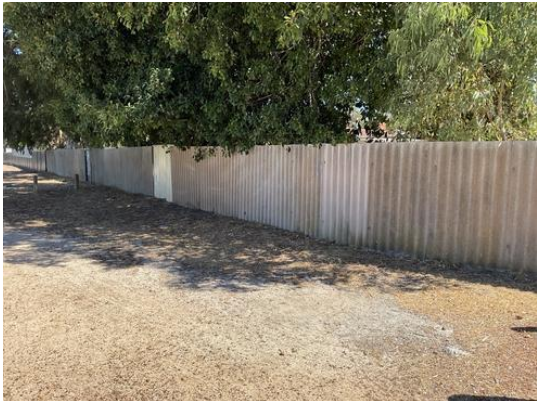
Photo 13	Photo 14	Photo 15
		Photo 16
		Photo 17
		Photo 18
Asbestos Containing Material		ACM suspected
Material type		Super six corrugated sheeting
Condition		Poor
Details on Condition:		Multiple areas of damage, vegetation rubbing on fence
Quantity sqm (apx)		250
Friable or Non-Friable		Non-Friable
Is this an inaccessible area?		Only accessed by maintenance staff / contractors
Actions for consideration:		
Consider safe removal & replace with non ACM	Consider enclosing the ACM through non ACM disturbance measures	Consider sealing the ACM appropriately
Monitor and Review the ACM's condition	Consider safely sampling the ACM for verification	Signify ACM present
Other details:		
Vegetation to be kept away from the fence to prevent material from becoming friable

Seal or remove and replace with non-ACM product		
Removal by a licenced asbestos contractor during refurbishment or demolition
