Shire of Mundaring

Asbestos Management Plan

Chidlow Hall –
Lot 385 Old Northam Road,
Chidlow WA 6556

12 February 2024

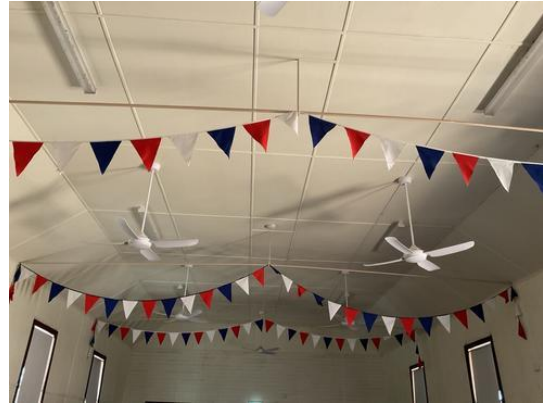
Photo 2

Main Hall Ceiling & Batons

ACM suspected
Hardiflex sheeting

Good

Sealed and intact

150

Non-Friable

Consider safe removal & replace with non ACM	Monitor and Review the ACM's condition	Consider safely sampling the ACM for verification
		Signify ACM present

Monitor and review for wear and damages

Removal by a licenced asbestos contractor during refurbishment or demolition

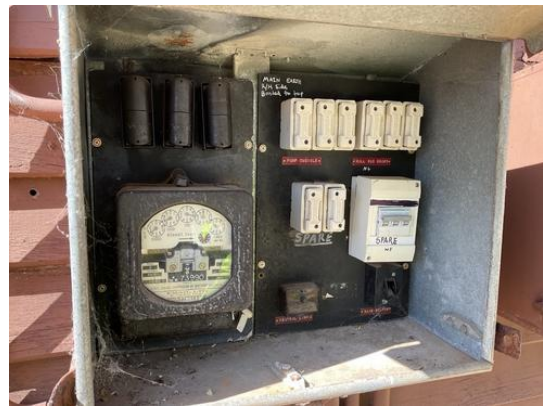
Photo 4

Electrical Switchboard & Ceramic Fuses

Zemolite

Good

Intact

.5

Non-Friable

Consider safe removal & replace with non ACM

Monitor and Review the ACM's condition

Signify ACM present

Monitor and review for wear and damages
