Shire of Mundaring

Asbestos Management Plan

Darlington Family Playgroup –
Lot 556 Lionel Road,
Darlington WA 6070

9 February 2024

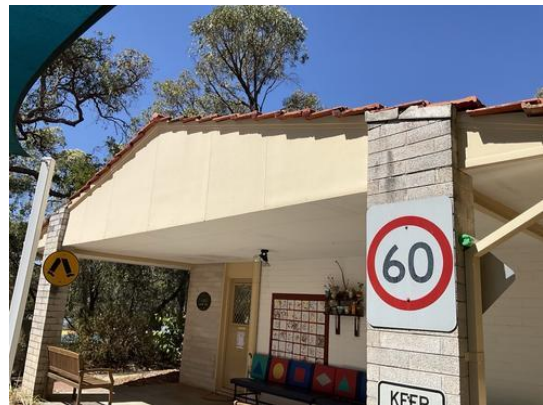
Photo 4

Eaves & Facia Panels

Assumed ACM

ACM suspected
Hardiflex sheeting

Good

Sealed and intact

100

Non-Friable

Consider safe removal & replace with non ACM	Monitor and Review the ACM's condition	Consider safely sampling the ACM for verification
		Signify ACM present

Monitor and review for wear and damages
