Shire of Mundaring

Asbestos Management Plan

Darlington Hall (Main Hall & Lesser Hall) –
Lot 37 Pine Terrace,
Darlington WA 6070

8 February 2024

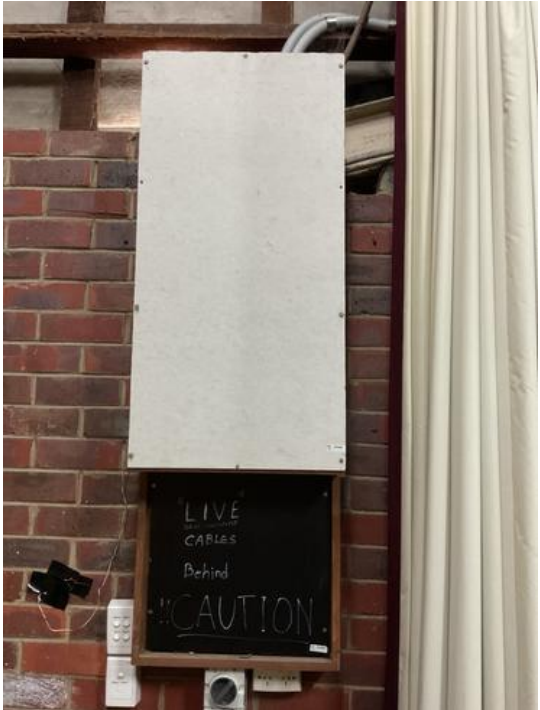
Photo 2

Stage Switchboard

ACM suspected	ACM tested
Material type		Hardiflex sheeting
Condition		Good
Details on Condition:		Intact
Quantity sqm (apx)		1
Friable or Non-Friable		Non-Friable
Is this an inaccessible area?		Accessible: unlikely to be damaged
Actions for consideration:		
Consider safe removal & replace with non ACM	Consider sealing the ACM appropriately	Monitor and Review the ACM's condition
	Consider safely sampling the ACM for verification	Signify ACM present

Testing has been conducted, presumed ACM as test results unknown
 Monitor and review for wear and damages
 Removal by a licenced asbestos contractor during refurbishment or demolition

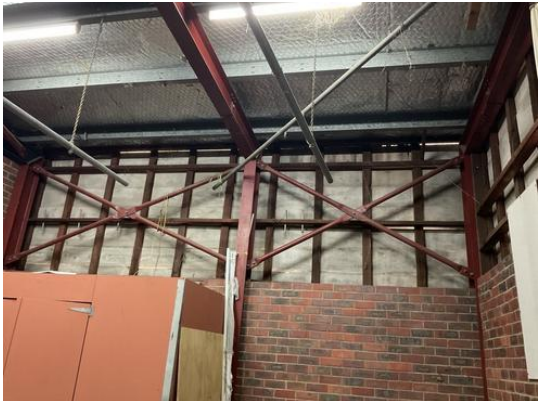
Photo 3

Facia Panels

ACM suspected
Hardiflex sheeting

Unsealed and intact

Consider safe removal & replace with non ACM	Consider enclosing the ACM through non ACM disturbance measures	Consider sealing the ACM appropriately
Monitor and Review the ACM's condition	Consider safely sampling the ACM for verification	Signify ACM present

Encapsulate or seal to prevent deterioration. Testing has been conducted, presumed ACM as test results unknown

Monitor and review for wear and damages
