Asbestos Management Plan

Glen Forrest Community Kindergarten &
Family Playgroup & Health Centre –
47 Marnie Road,
Glen Forrest WA 6071

9 February 2024

Site Inspection for Asbestos Containing Materials

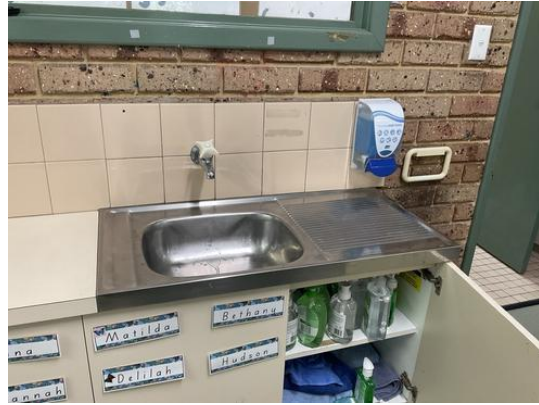
Photo 2

Playroom Sink Blackjack Spray Resin Backing

Blackjack spray resin backing

Good

Intact

Accessible: potential to be damaged

Consider encapsulating to prevent damage when storing items

Monitor and review for wear and damages
