Asbestos Management Plan

Lake Leschenaultia – Breezeway Office –
2135 Rosedale Road,
Chidlow WA 6556

6 February 2024

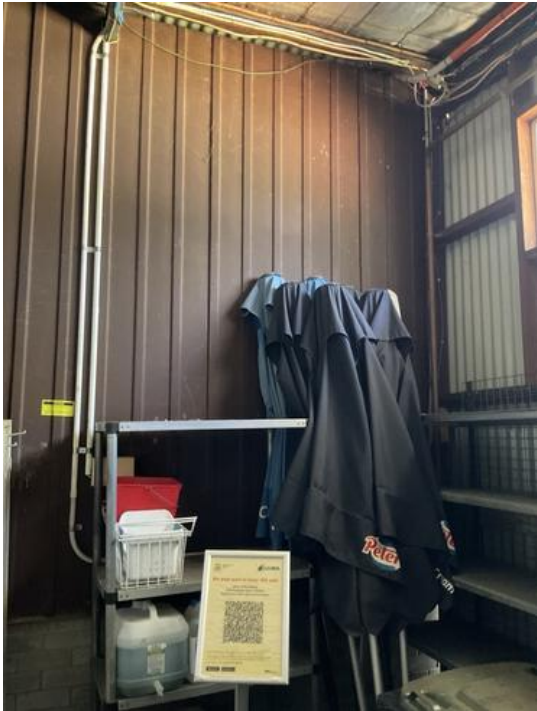
Photo 2

Shadowline Cladding Storage Area

Assumed ACM

Non-Friable
Accessible: potential to be damaged

Seal damaged area and instruct workers/contractors of ACM hazard

Monitor and review for wear and damages

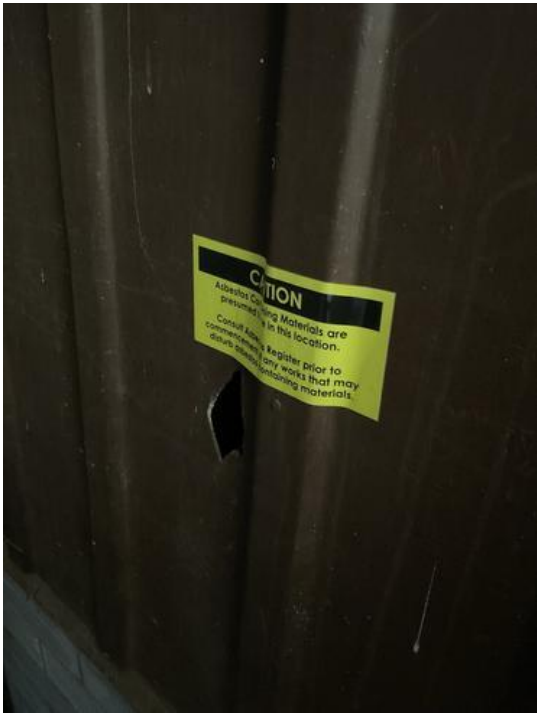
Photo 8

Damage to hose hook and hole below
