Shire of Mundaring

Asbestos Management Plan

Mundaring & Lesser Hall –
Lot 46 Nichol Street,
Mundaring WA 6073

7 February 2024

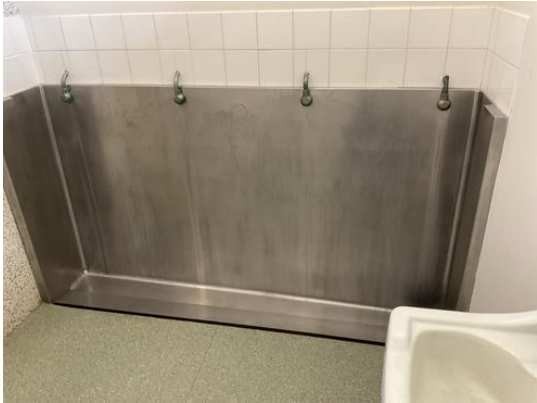
Photo 2

Foyer Male Toilet Urinal Blackjack Spray Resin Backing

Blackjack spray resin backing

Good

Assumed intact

4

Non-Friable

Consider safe removal & replace with non ACM	Monitor and Review the ACM's condition	Consider safely sampling the ACM for verification
Signify ACM present

Monitor and review for wear and damages

Removal by a licenced asbestos contractor during refurbishment or demolition

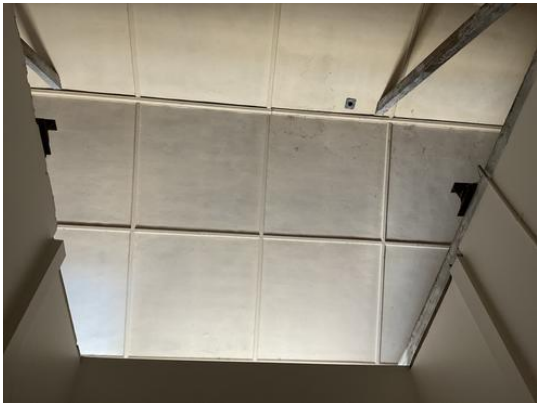
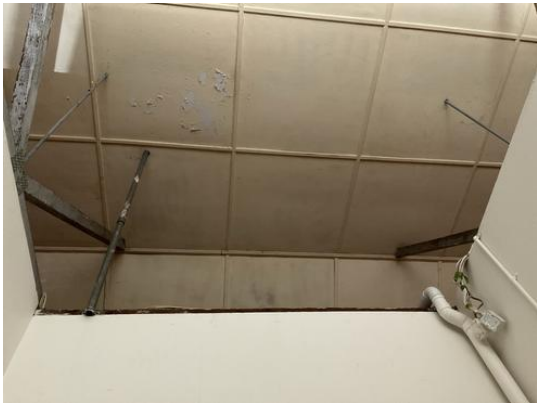
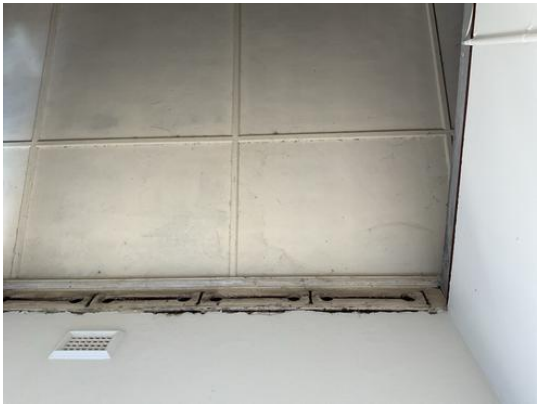
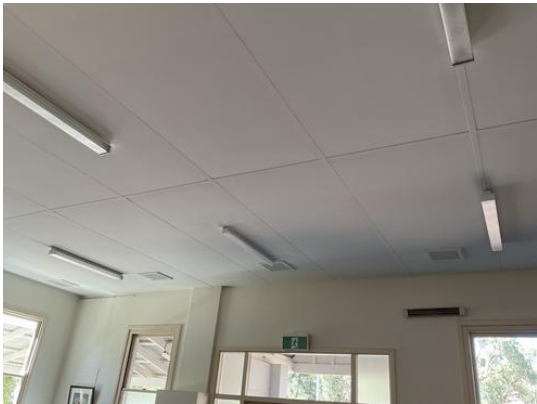
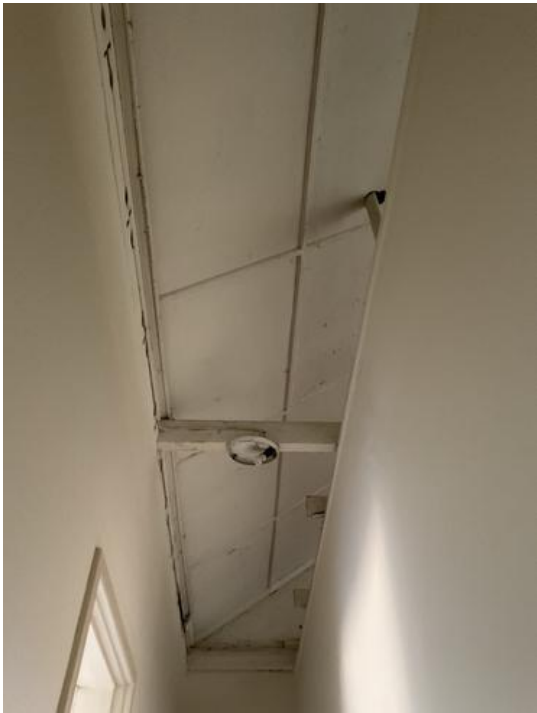
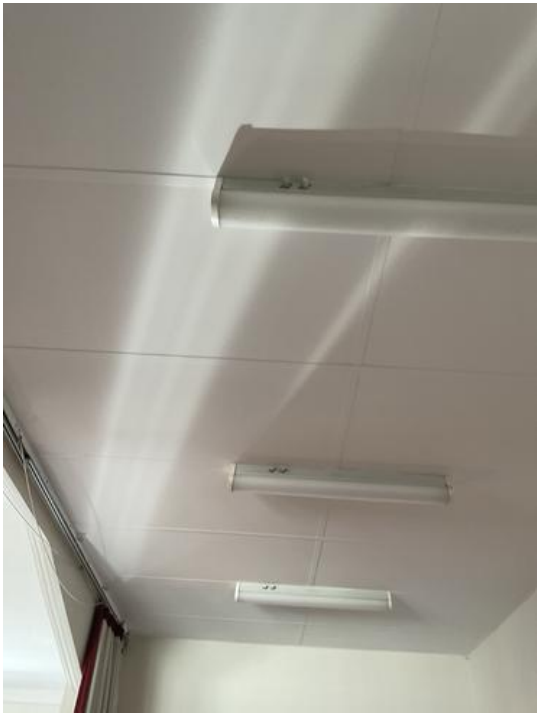
Stage, Jacoby Entrance & Storerooms Ceiling

ACM suspected
Hardiflex sheeting

Good

Sealed and intact

100

Consider safe removal & replace with non ACM	Monitor and Review the ACM's condition	Consider safely sampling the ACM for verification
Signify ACM present

Monitor and review for wear and damages
