Shire of Mundaring

Asbestos Management Plan

Mundaring Child Health Clinic & Toy Library –
12 Craig Street,
Mundaring WA 6073

12 February 2024

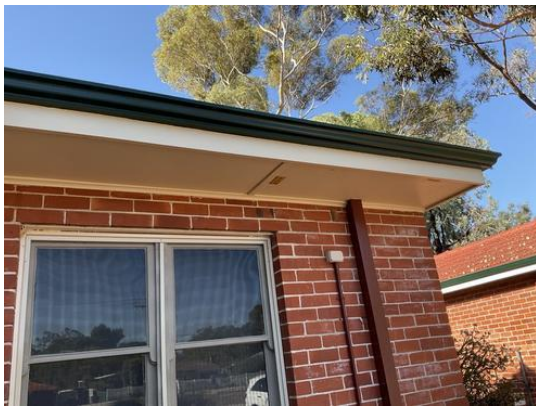
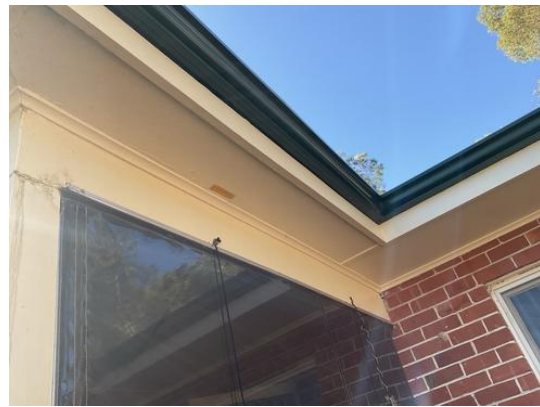
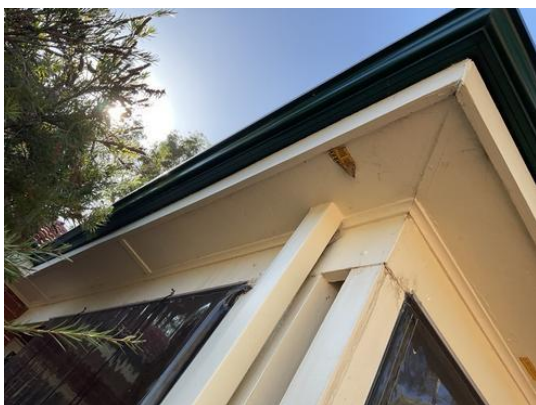
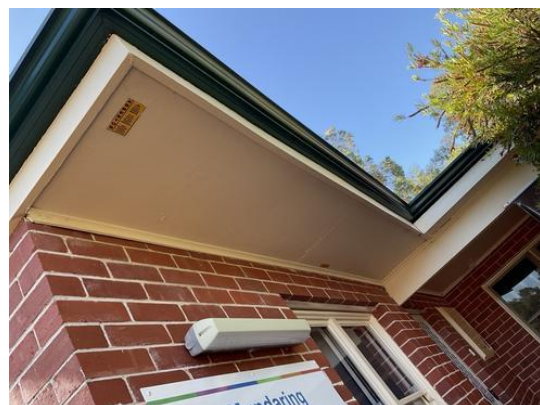
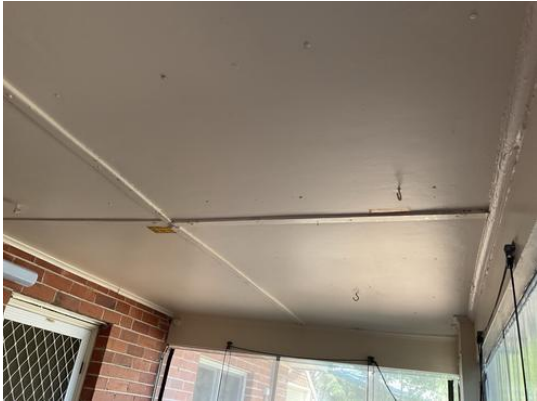
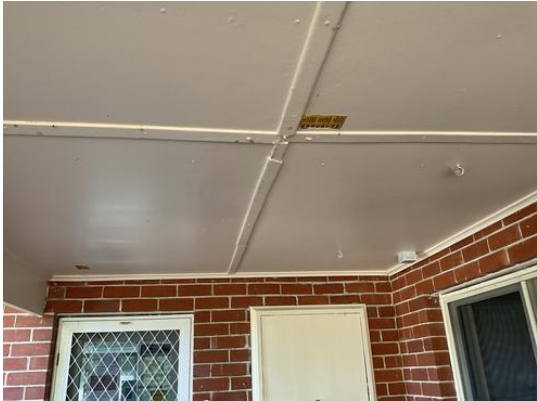
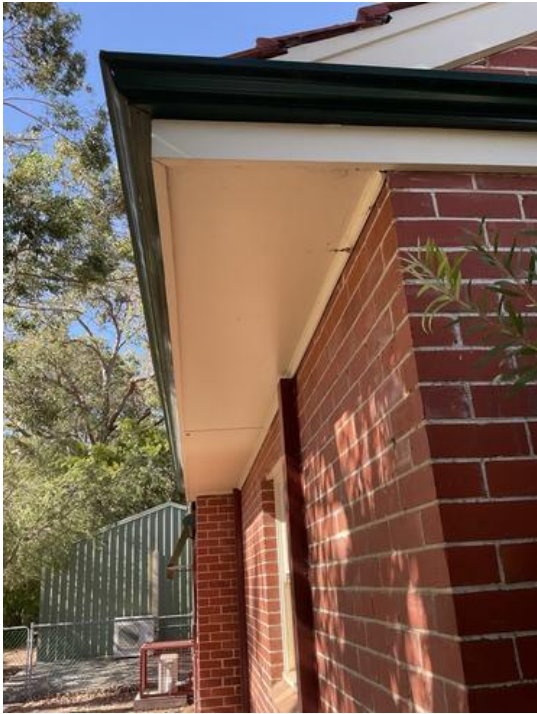
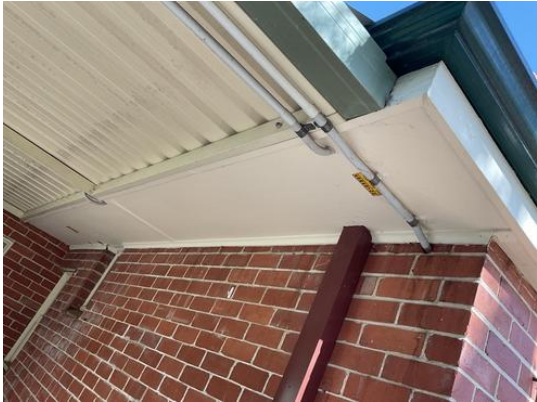
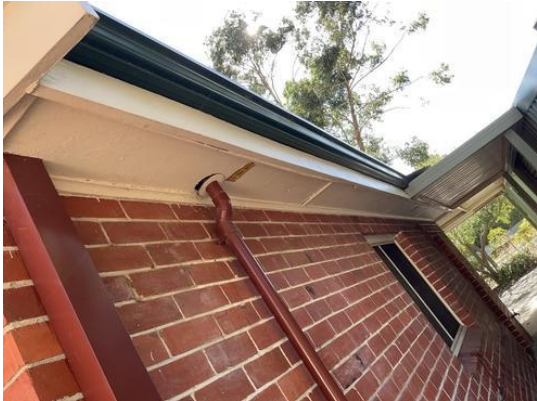
Describe location of the ACM/Presumed ACM

External Eaves

Assumed ACM

Condition

Good

Consider safe removal & replace with non ACM

Monitor and Review the ACM's condition

Keep vegetation away from ACM product to prevent damage and material becoming friable

Monitor and review for wear and damages
