Shire of Mundaring

Asbestos Management Plan

Octagonal Hall –
52 McGlew Road,
Glen Forrest WA 6071

8 February 2024

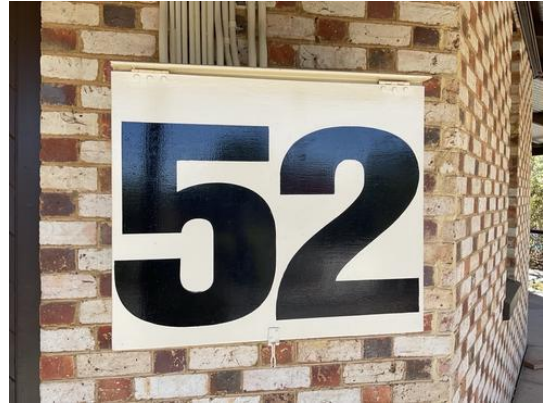
Photo 2

Exterior Electrical Switchboard

Zemolite

Good

Intact

.5

Non-Friable

Monitor and review for wear and damages

Removal by a licenced asbestos contractor during refurbishment or demolition.
