Shire of Mundaring

Asbestos Management Plan

Administration & Civic Complex –
7000 Great Eastern Highway,
Mundaring WA 6073

7 February 2024

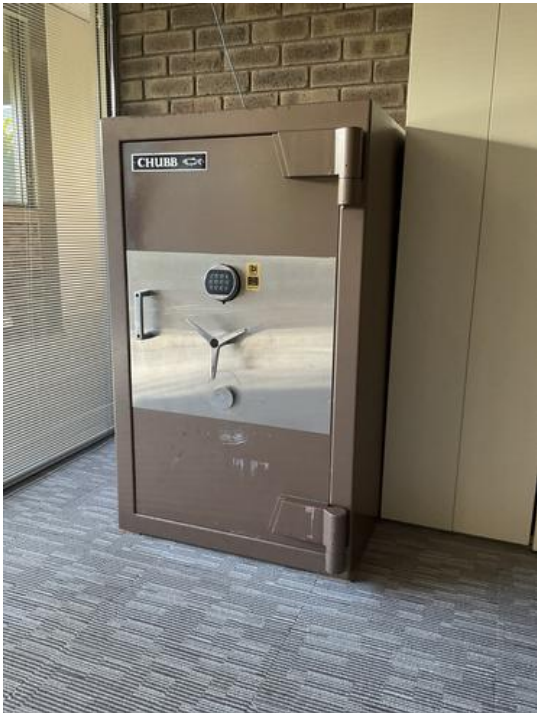
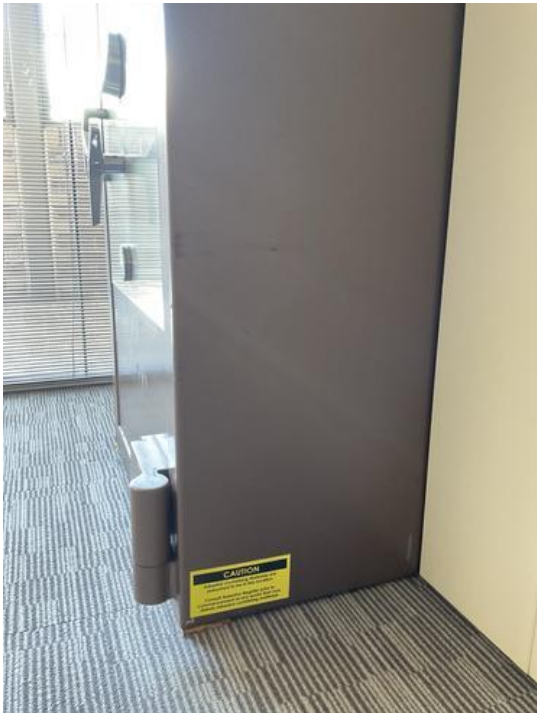
Photo 3 Photo 4

Floor Safe Insulation

Assumed ACM

Insulation within safe

Good

Assumed intact

2

Non-Friable

Only accessed by maintenance staff / contractors

Consider safe removal & replace with non ACM	Monitor and Review the ACM's condition	Consider safely sampling the ACM for verification
Signify ACM present

Monitor and review for wear and damages

Removal by a licenced asbestos contractor during refurbishment or demolition

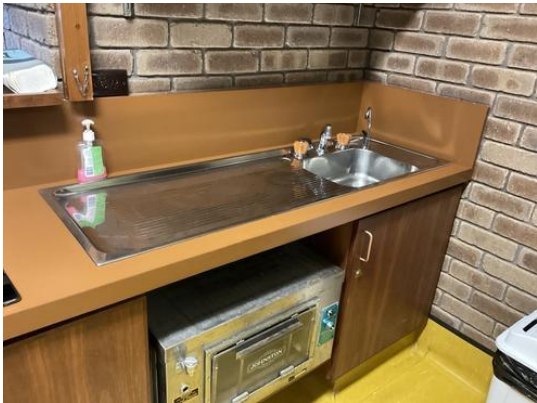
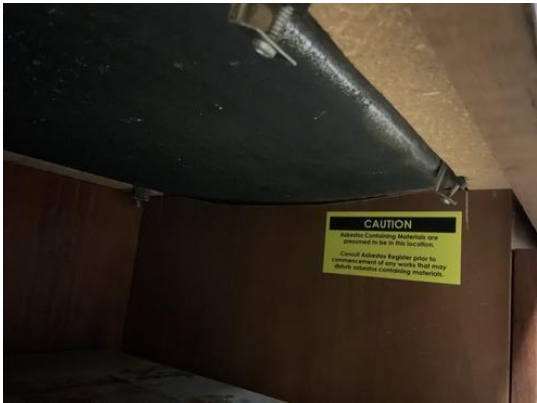
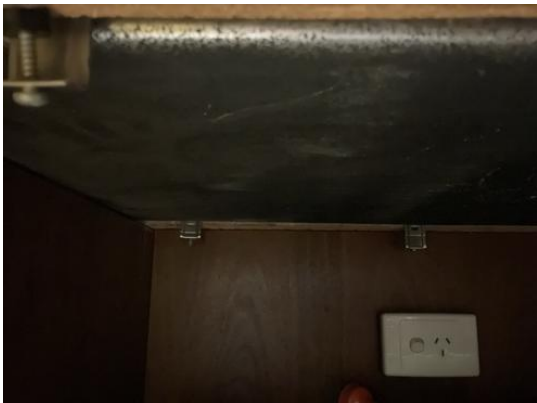
Civic Room Bar Sink Blackjack Spray Resin Backing

Assumed ACM

Good

Intact

2

Non-Friable

Accessible: potential to be damaged

Consider safe removal & replace with non ACM	Consider enclosing the ACM through non ACM disturbance measures	Monitor and Review the ACM's condition
	Consider safely sampling the ACM for verification	Signify ACM present

- Enclose underneath sink to prevent damage and deterioration to Blackjack spray resin
- Monitor and review for wear and damages
- Removal by a licenced asbestos contractor during refurbishment or demolition
