Shire of Mundaring

Asbestos Management Plan

Albert Facey Mundaring Library –
1 Nichol Street,
Mundaring WA 6073

Site Inspection for Asbestos Containing Materials

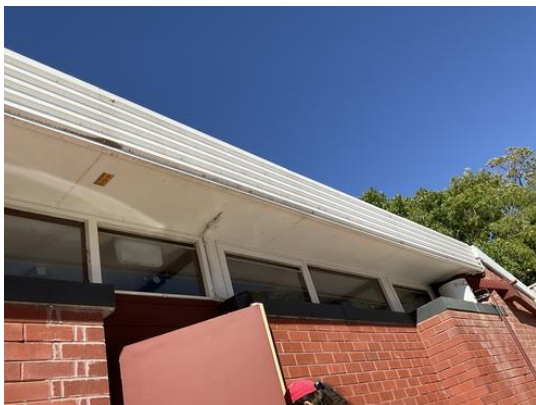
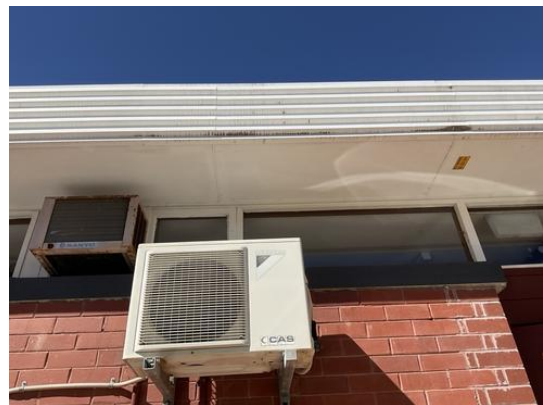
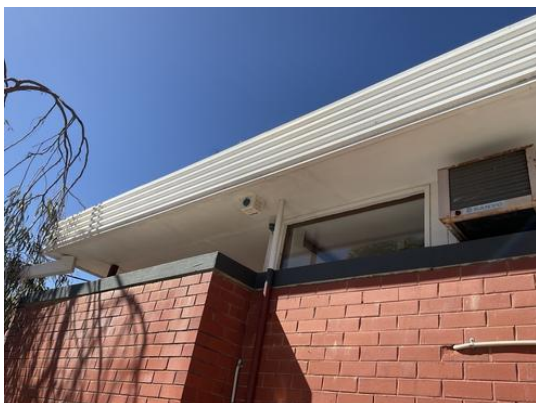
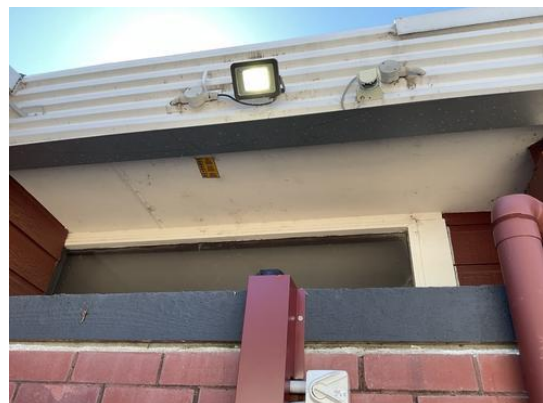
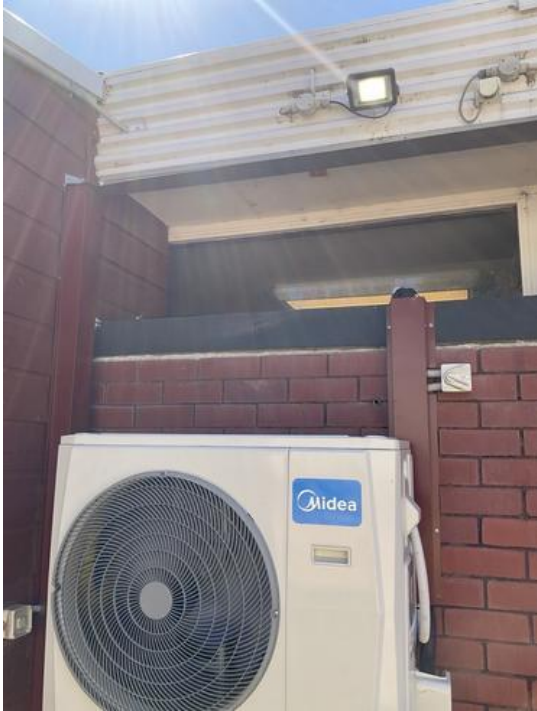
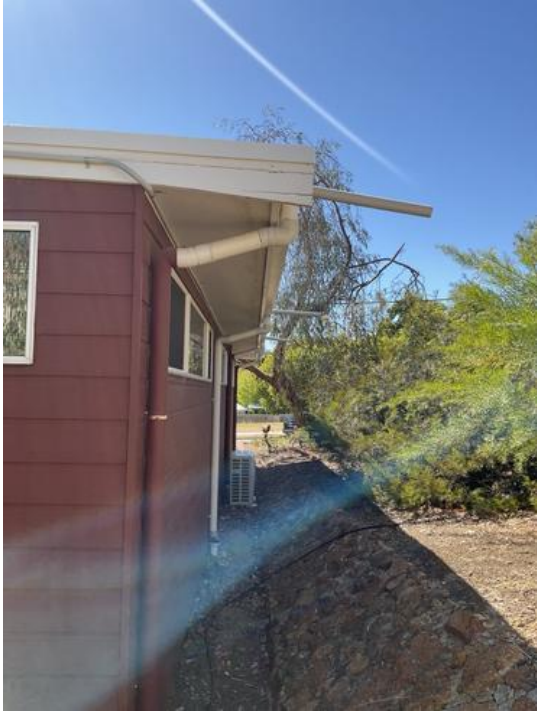
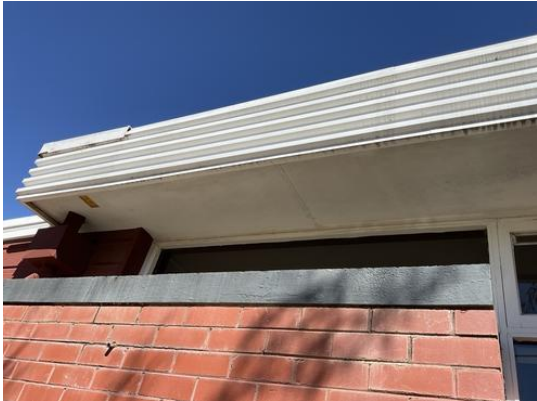
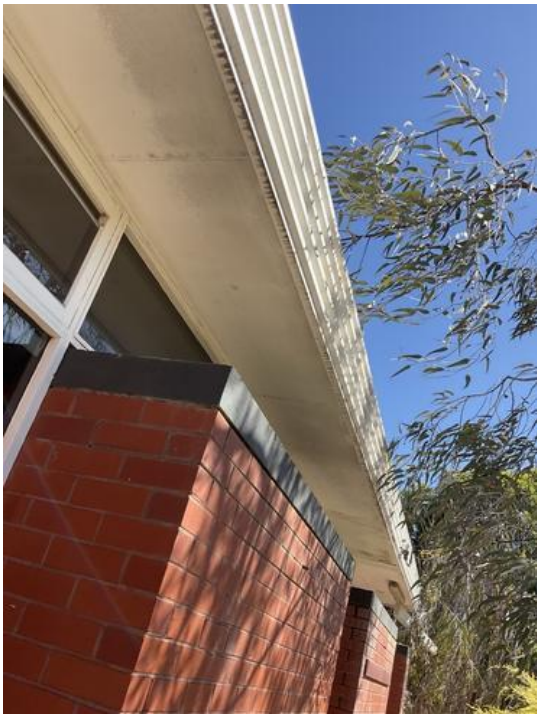
External Eaves

Assumed ACM

Hardiflex sheeting

Good

Sealed and intact

30

Non-Friable

Consider safe removal & replace with non ACM

Monitor and Review the ACM's condition

Consider safely sampling the ACM for verification

Signify ACM present

Monitor and review for wear and damages

Removal by a licenced asbestos contractor during refurbishment or demolition

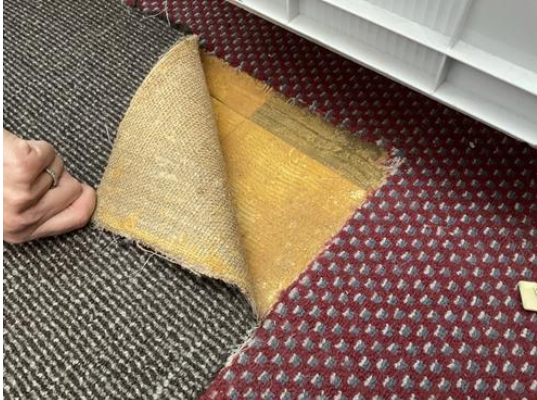
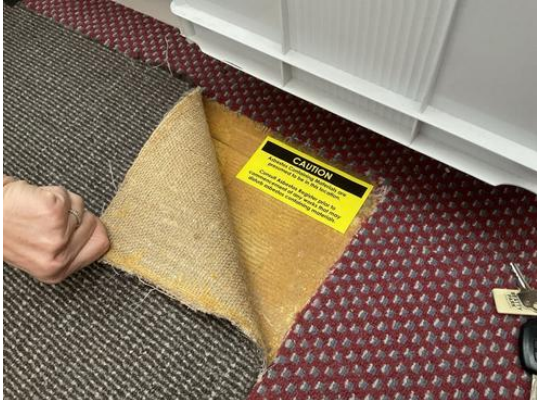
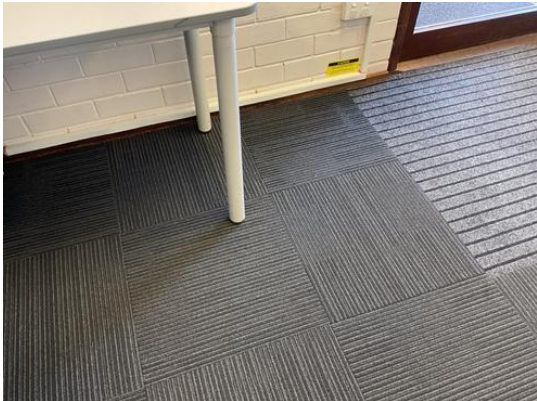
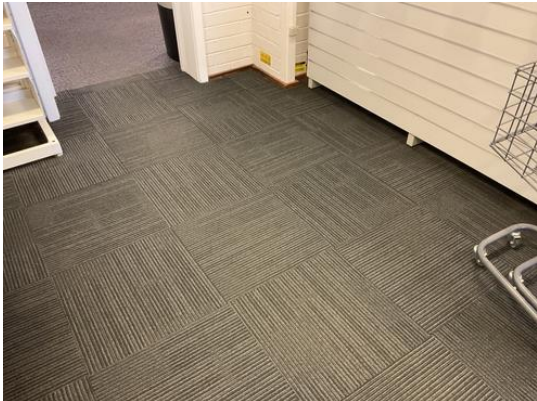
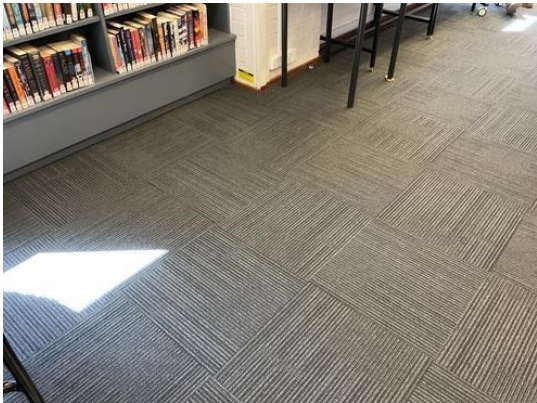
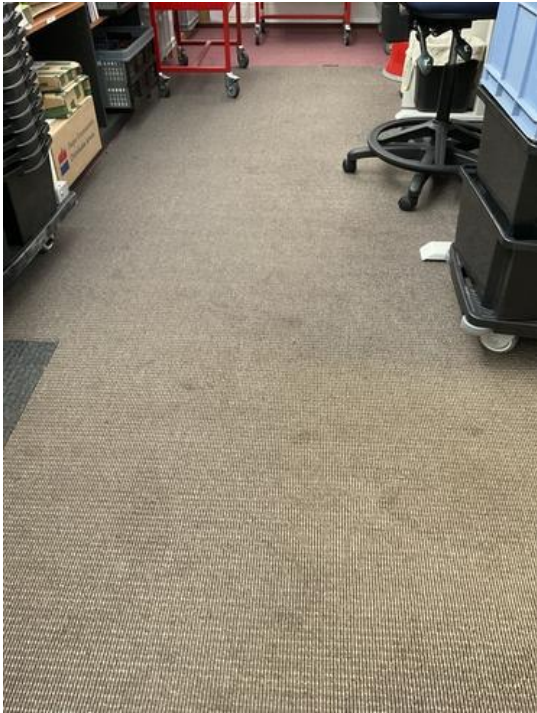
Vinyl Tile Encapsulated Under Carpet

Assumed ACM

AC vinyl floor tiles

Good

Consider safe removal & replace with non ACM

Monitor and Review the ACM's condition

Monitor and review for wear and damages
