Asbestos Management Plan

Brown Park Community Centre –
116 Salisbury Road,
Swan View WA 6056

8 February 2024

Brown Park Community Centre

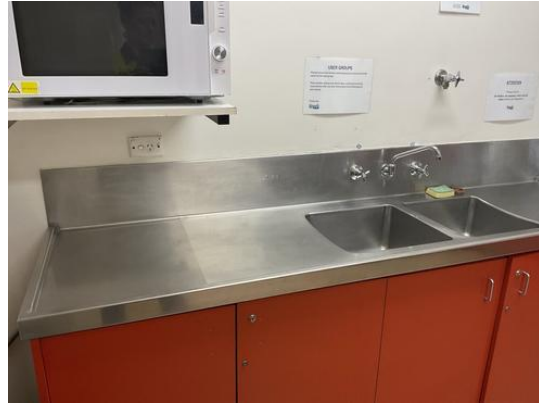
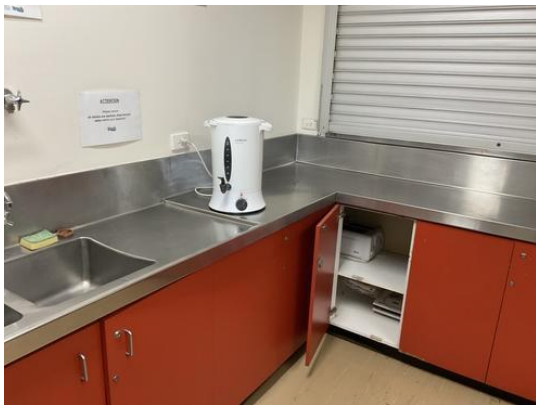
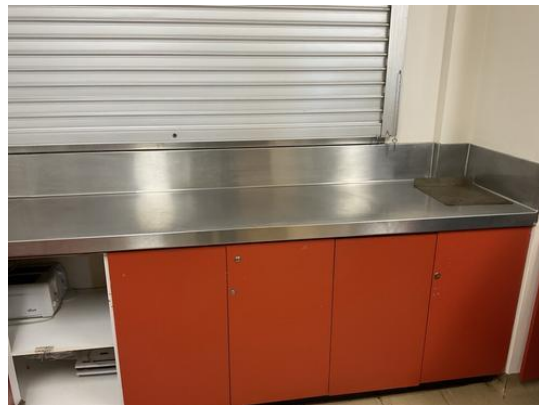
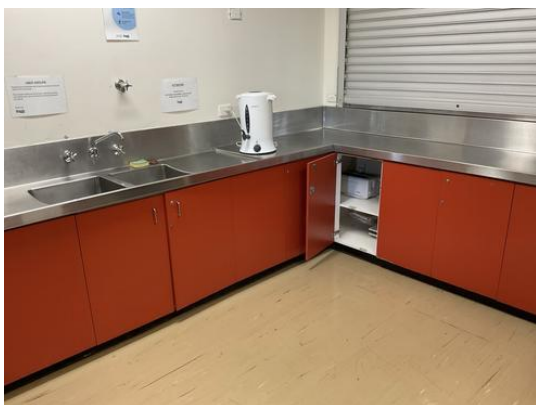
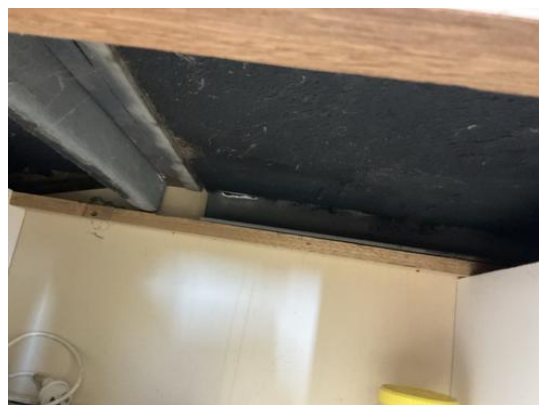
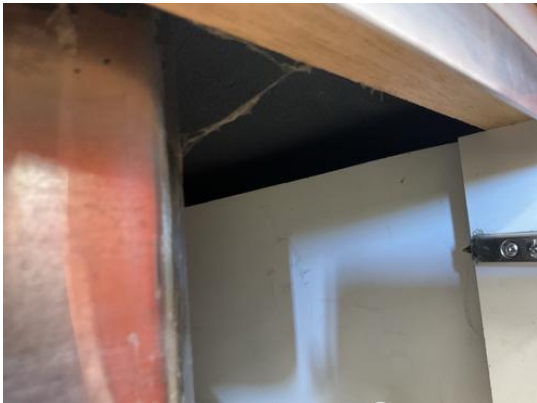
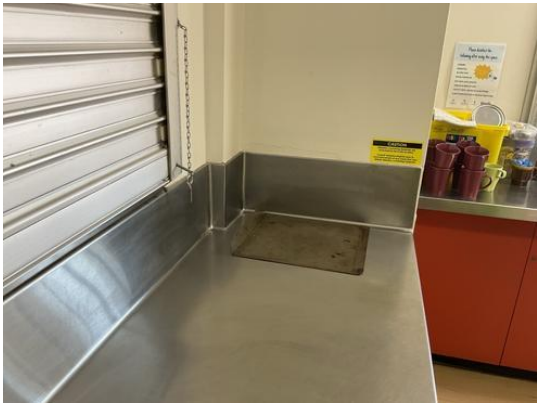
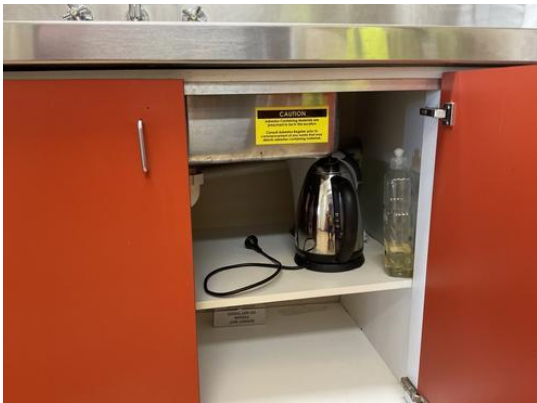
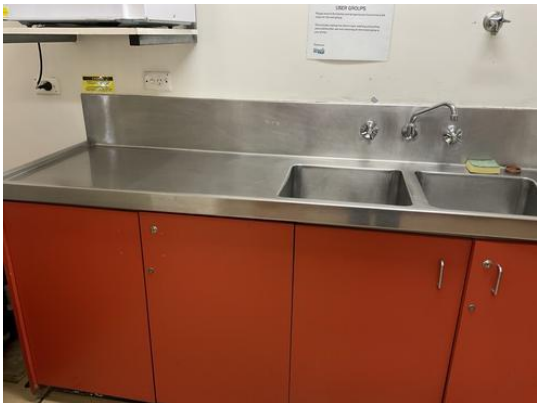
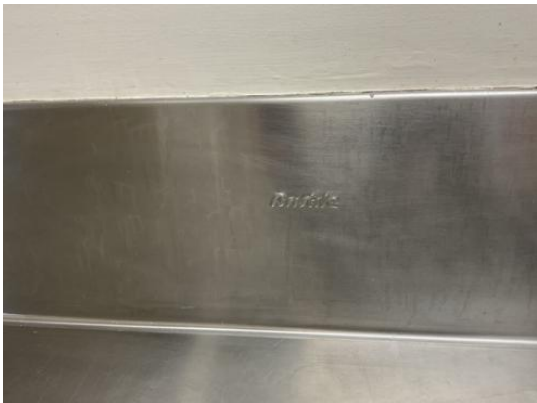
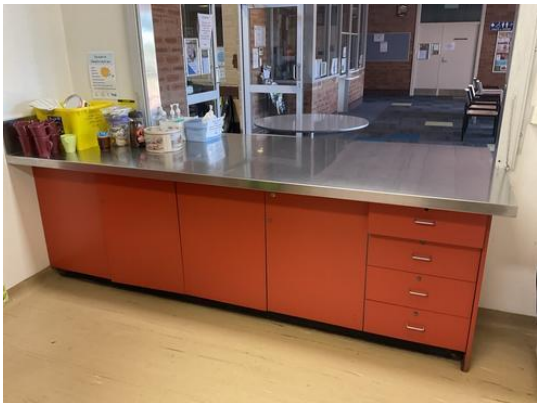
Brown Park Kitchen Sink Blackjack Spray Resin Backing

Blackjack spray resin backing

Good

Intact

15

Non-Friable

Consider safe removal & replace with non ACM	Consider enclosing the ACM through non ACM disturbance measures	Monitor and Review the ACM's condition
	Consider safely sampling the ACM for verification	Signify ACM present

Consider encapsulating to prevent damage

Island bar bench considered the same as sink

Monitor and review for any damage
