Surface Water and Drainage Management Plan

Report on
SURFACE WATER AND DRAINAGE
MANAGEMENT PLAN
PROPOSED CHILDCARE CENTRE
40 MARLBORO ROAD
SWAN VIEW, WA

PROPOSED CHILDCARE CENTRE

40 MARLBORO ROAD, SWAN VIEW, WA

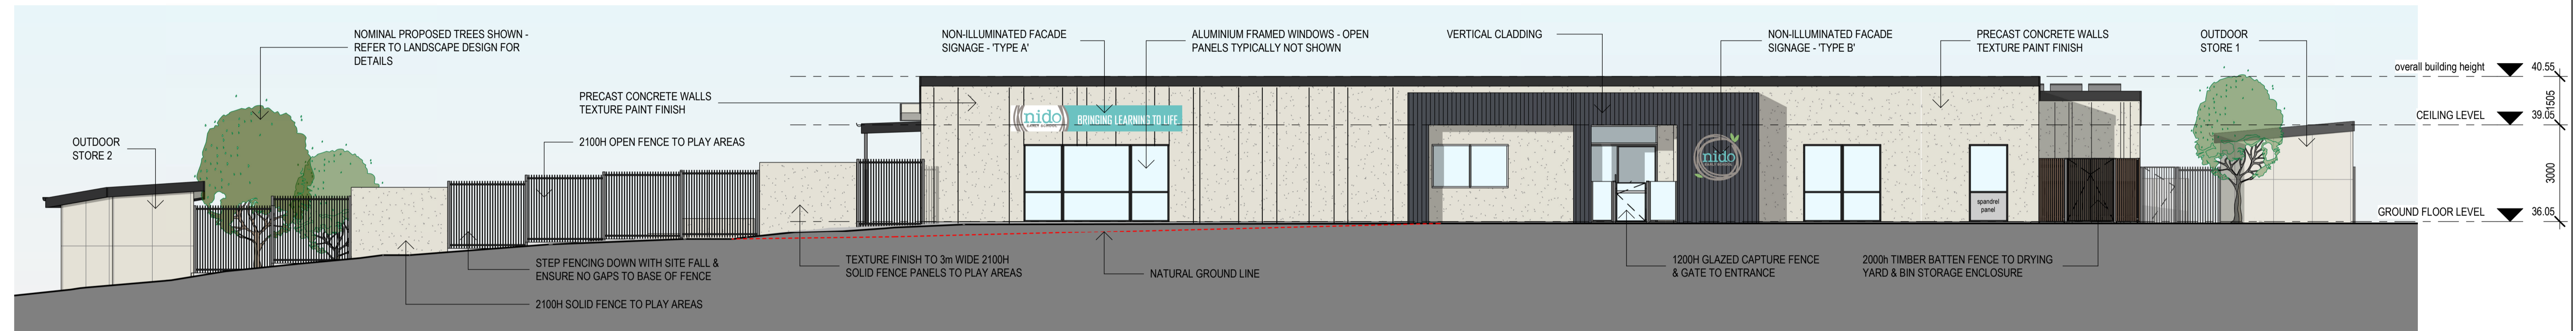
FENCE HEIGHT
ENSURE ALL PLAYSCAPE FENCING COMPLIES WITH AS1926.1 WITH MINIMUM INTERNAL HEIGHT OF 2.1m AND MINIMUM EXTERNAL HEIGHT OF 1.2m.
