# Asbestos Management Plan

Darlington Bushfire Brigade –  
5 – 13 Pine Terrace,  
Darlington WA 6070

5 February 2024

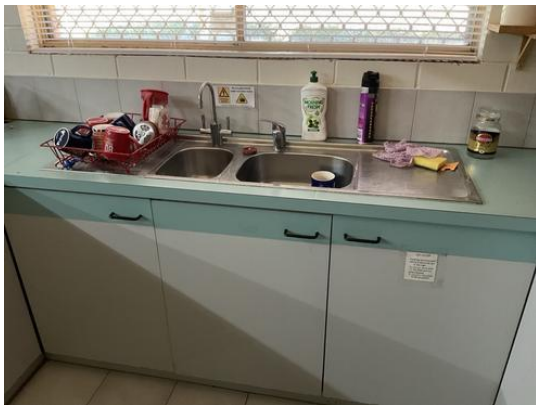
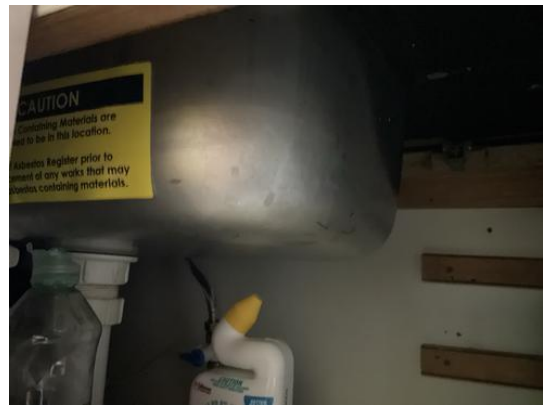
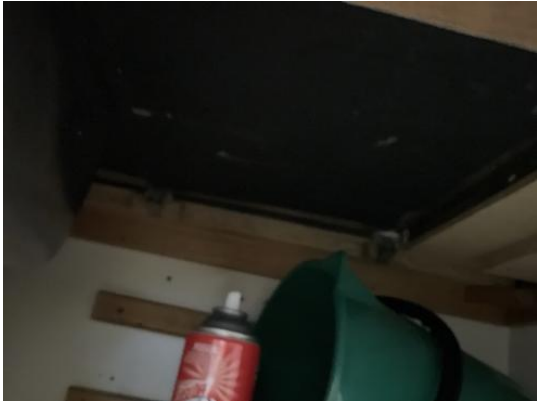
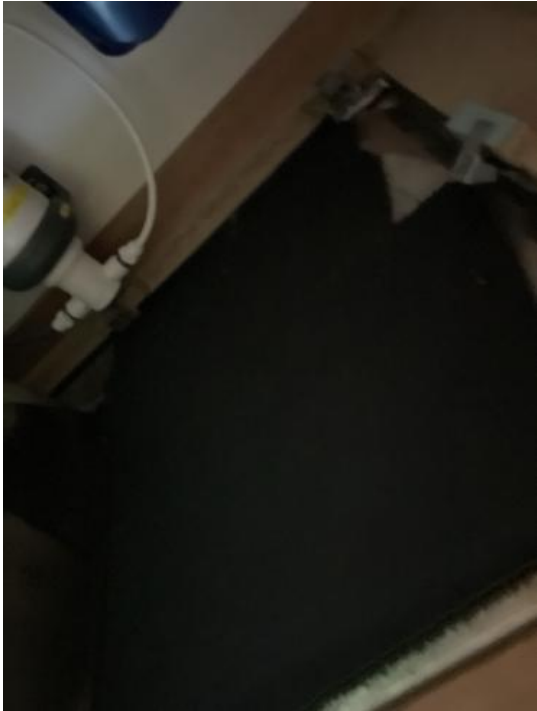
Meeting Room Kitchen Sink - Blackjack Spray Resin Backing

Blackjack spray resin backing

Good

Intact

2

Non-Friable

Accessible: unlikely to be damaged

Consider safe removal & replace with non ACM	Consider enclosing the ACM through non ACM disturbance measures	Monitor and Review the ACM's condition
	Consider safely sampling the ACM for verification	Signify ACM present

Consider encapsulating to prevent accidental damage

Monitor for wear and damages

Removal by a licenced asbestos contractor during refurbishment or demolition
