Shire of Mundaring

Asbestos Management Plan

Depot Mechanical Workshop –
25 Darkan Street,
Mundaring WA 6073

6 February 2024

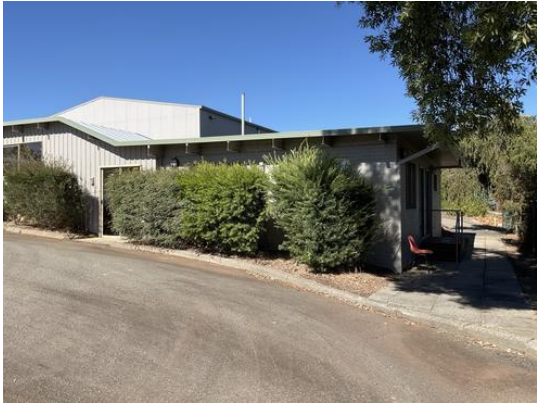
Photo 1

Depot -
Mechanical Workshop

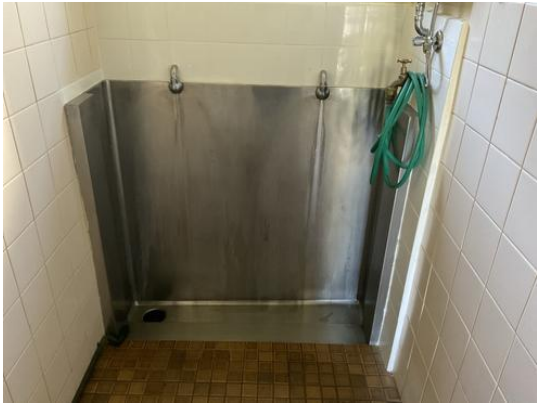
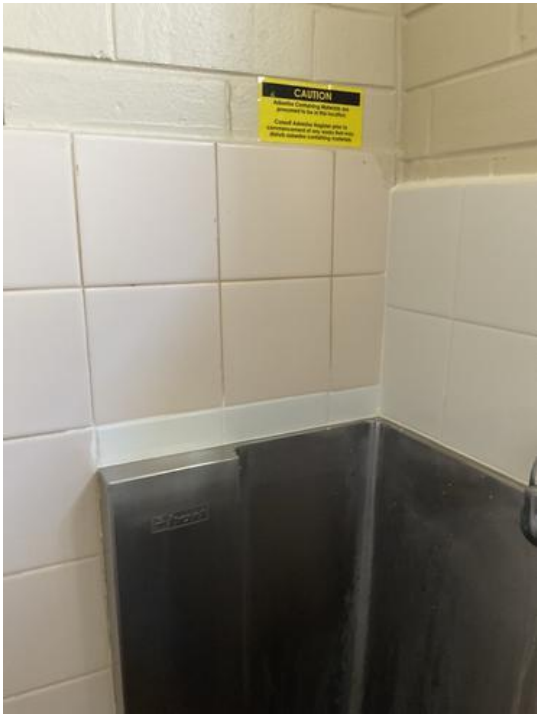
Photo 3

Toilets and Change Rooms Urinal Blackjack Spray Resin Backing

ACM suspected
Other
Blackjack spray resin backing
Good
Assumed intact
2
Non-Friable
Only accessed by maintenance staff / contractors

Monitor and review for wear and damages
 Removal by a licenced asbestos contractor during refurbishment or demolition
