Asbestos Management Plan

Glen Forrest Hall –
Lot 342 Marnie Road,
Glen Forrest WA 6071

5 February 2024

Glen Forrest Hall

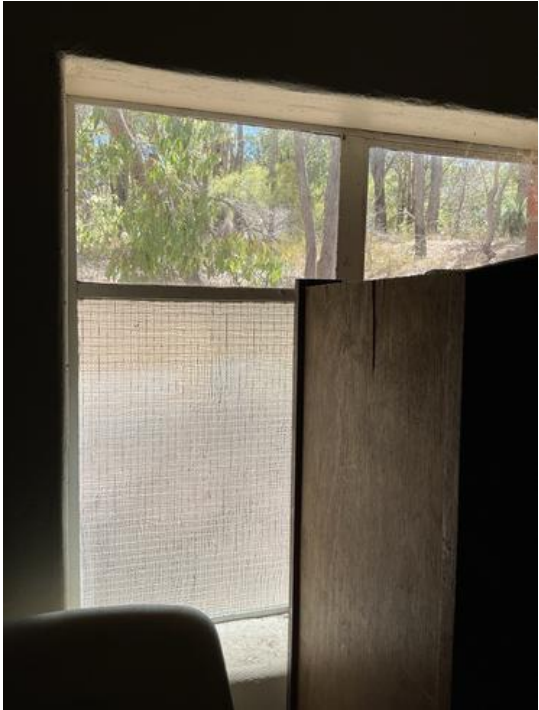
Photo 2

Storeroom Window Right of Stage Window Putty

ACM suspected
Window putty
Poor
Brittle and deteriorating
1
Non-Friable
Only accessed by maintenance staff / contractors

Seal or remove and replace with non-ACM product

Removal by a licenced asbestos contractor during refurbishment or demolition
