Shire of Mundaring

# Asbestos Management Plan

Lake Leschenaultia – Ticket Office  
(Entry Kiosk) –  
2135 Rosedale Road,  
Chidlow WA 6556

6 February 2024

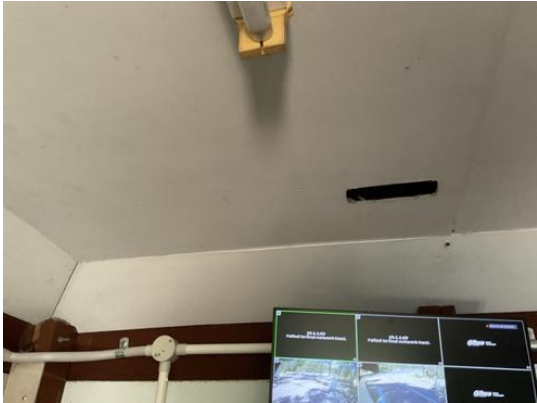
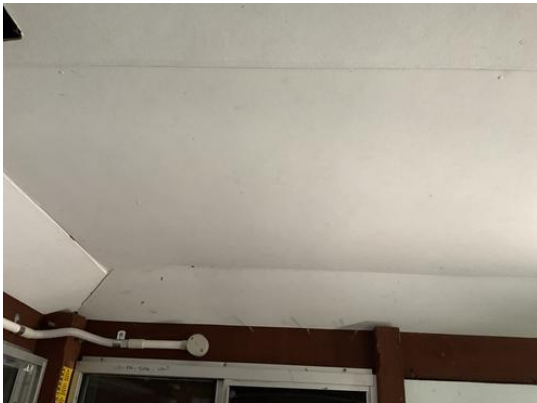
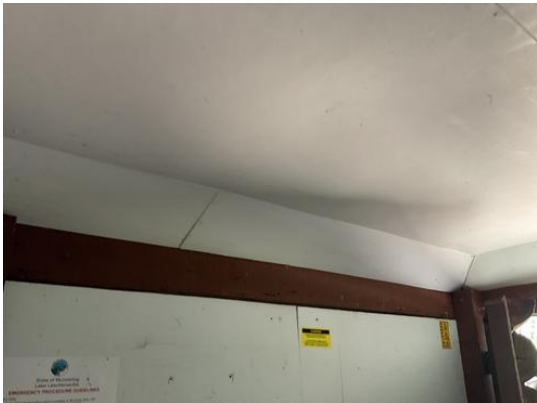
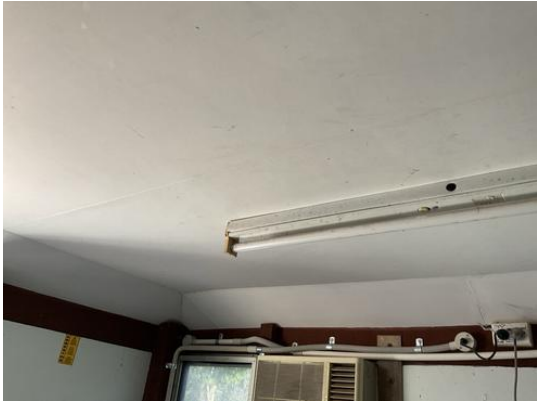
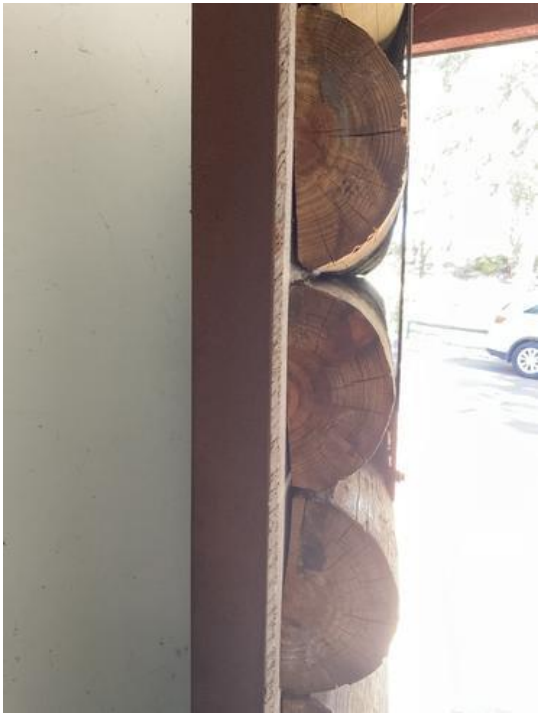
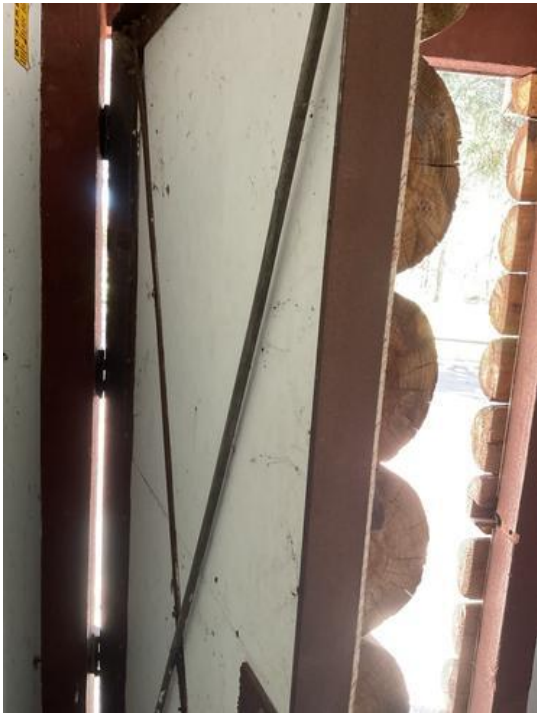
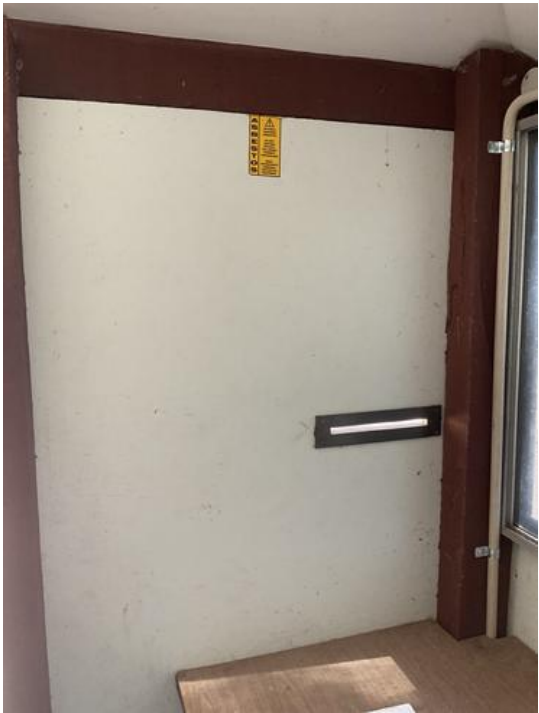
Internal Cladding Panels

ACM suspected
Hardiflex sheeting
<b>Good</b>
Sealed and intact
20
<b>Non-Friable</b>
Only accessed by maintenance staff / contractors

Testing required as panels do not match recognised ACM characteristics

Consider safe removal & replace with non ACM	Monitor and Review the ACM's condition	Consider safely sampling the ACM for verification
Signify ACM present

Monitor and review for wear and damages

Removal by a licenced asbestos contractor during refurbishment or demolition
