# Asbestos Management Plan

Mundaring Rec Ground Pavilion –  
Changerooms –  
Lot 12770 Mundaring Weir,  
Mundaring WA 6073

6 February 2024

**Site Inspection for Asbestos Containing Materials**

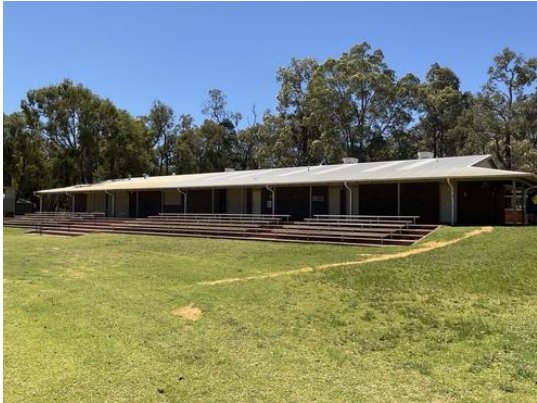
Photo 1

Mundaring Rec Ground Pavilion - Changerooms

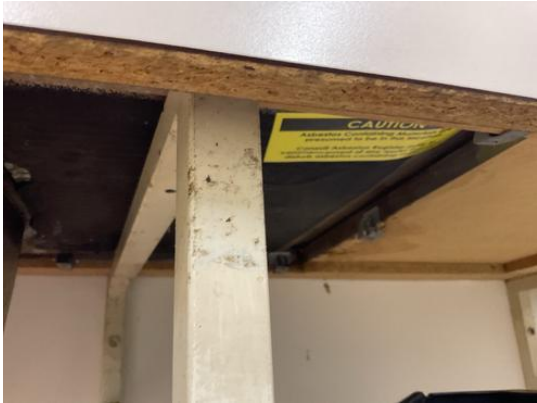
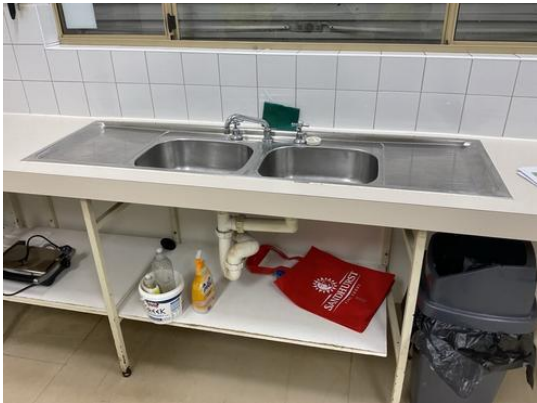
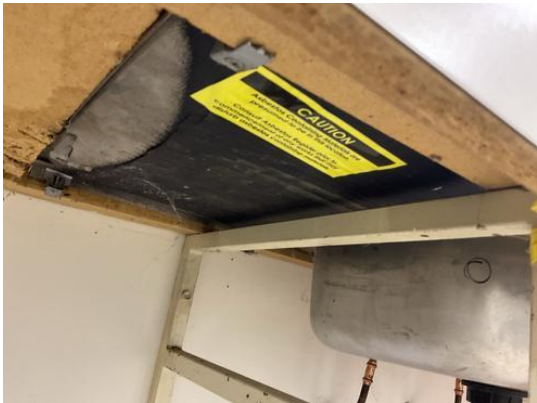
Kitchen Sink Blackjack Spray Resin Backing

Blackjack spray resin backing

Good

Intact

2

Non-Friable

Accessible: unlikely to be damaged

Consider safe removal & replace with non ACM	Monitor and Review the ACM's condition	Consider safely sampling the ACM for verification
Signify ACM present

Monitor and review for wear and damages

Removal by a licenced asbestos contractor during refurbishment or demolition
