# Asbestos Management Plan

Mundaring Scout Hall –  
3045 Jacoby Street,  
Mundaring WA 6073

14 February 2024

**Site Inspection for Asbestos Containing Materials**

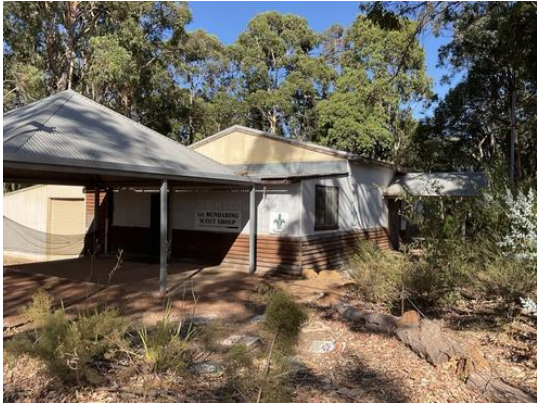
Photo 1

Mundaring Scout Hall

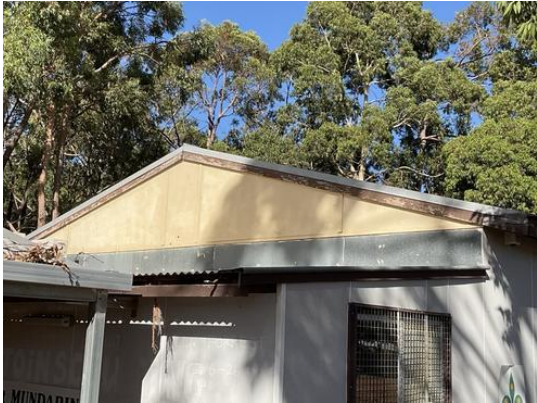
Photo 2

Gable End Panels & Batons

Hardiflex sheeting

Good

Sealed and intact

20

Non-Friable

Consider safe removal & replace with non ACM	Monitor and Review the ACM's condition	Consider safely sampling the ACM for verification
Signify ACM present

Monitor and review for wear and damages

Removal by a licenced asbestos contractor during refurbishment or demolition
