Shire of Mundaring

Asbestos Management Plan

Vacant Block –
8 Craig Street,
Mundaring WA 6073

7 February 2024

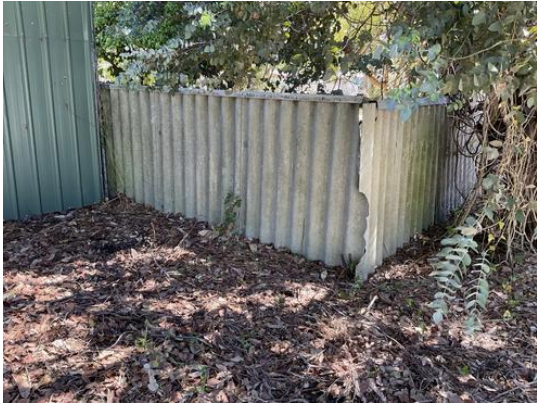
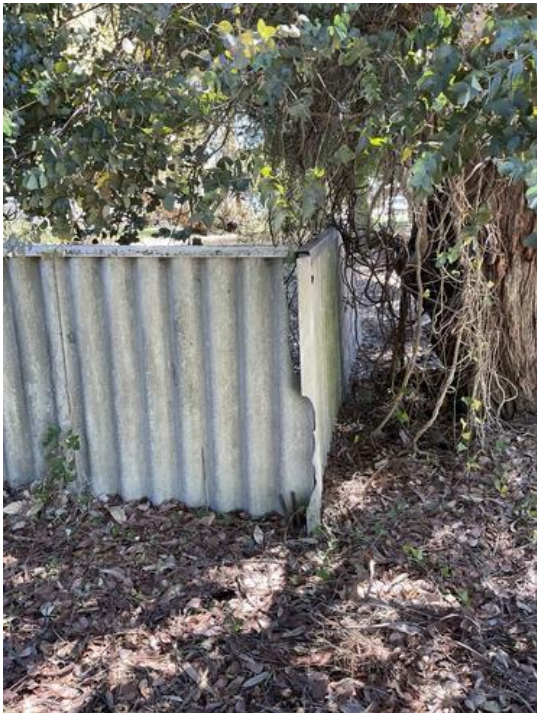
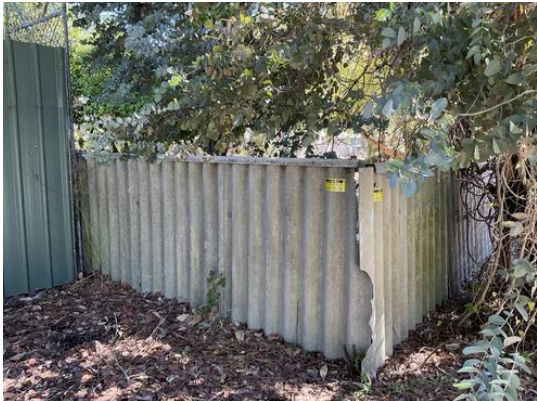
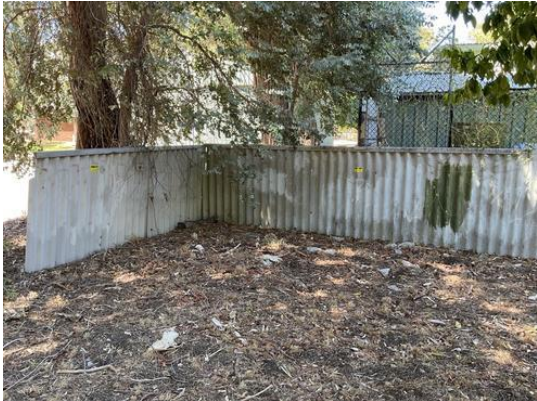
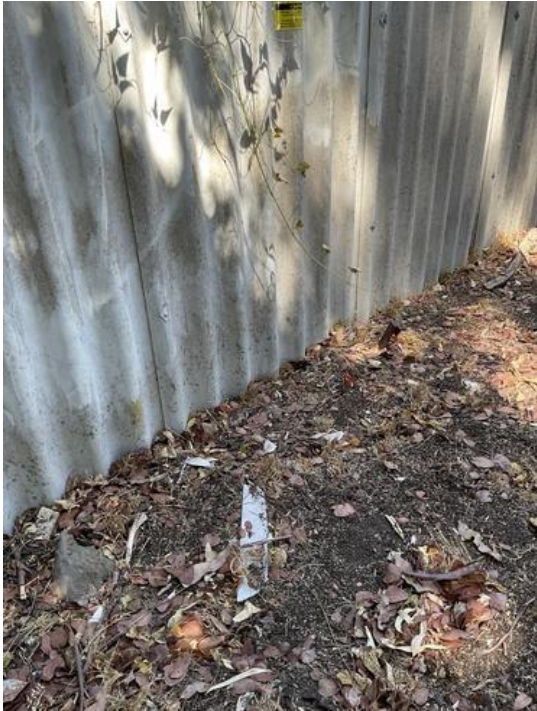
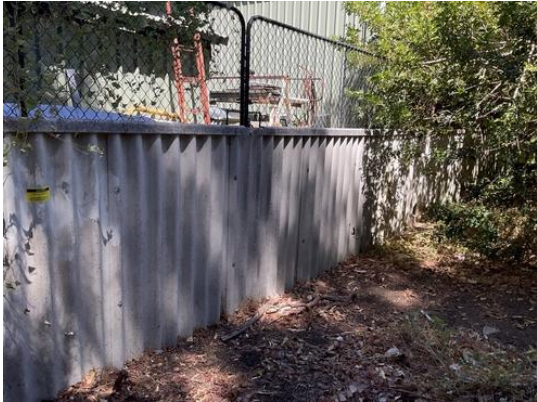
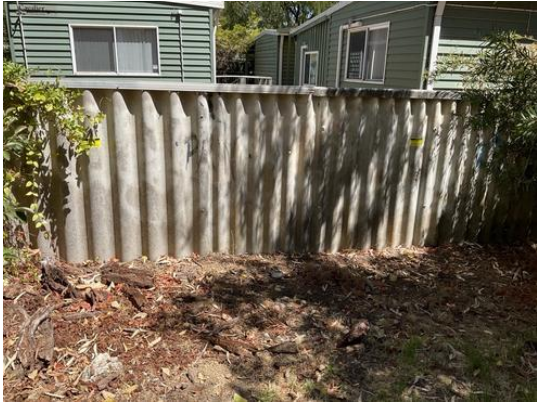
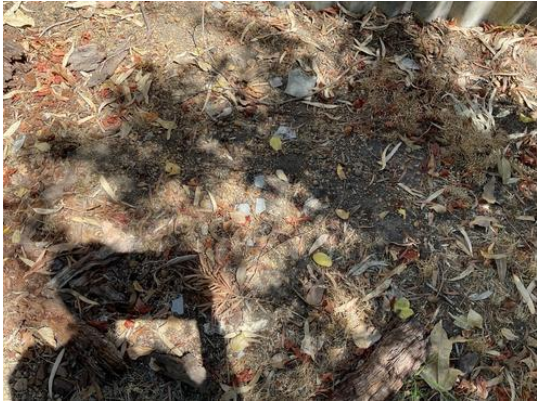
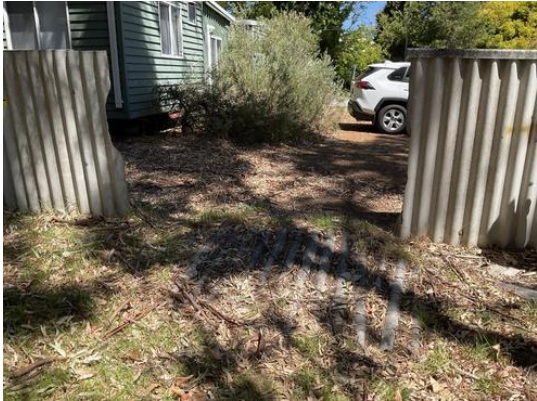
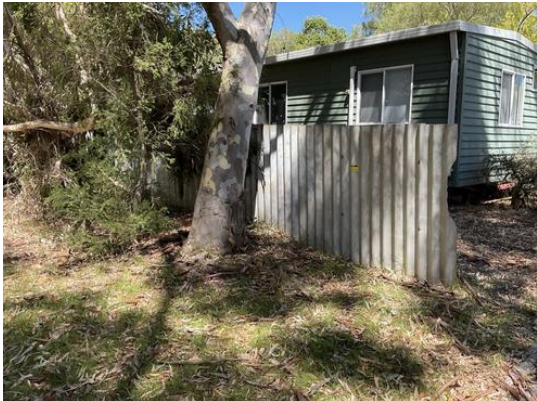
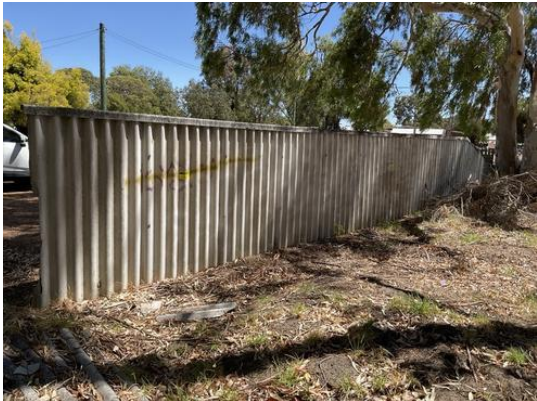
Boundary Fence and Ridge Capping

ACM suspected
Super six corrugated sheeting

Poor

Damaged and deteriorating

150

Non-Friable

Accessible: potential to be damaged

Consider safe removal & replace with non ACM

Remove vegetation from fence to prevent further damage and material becoming friable
Emu bob around the site to remove ACM debris. Fence panel on ground deteriorating
further via foot traffic
Remove and replace with non-ACM product
